Troubleshooting# 04

Revised 01/11/01

Got the right sensor?

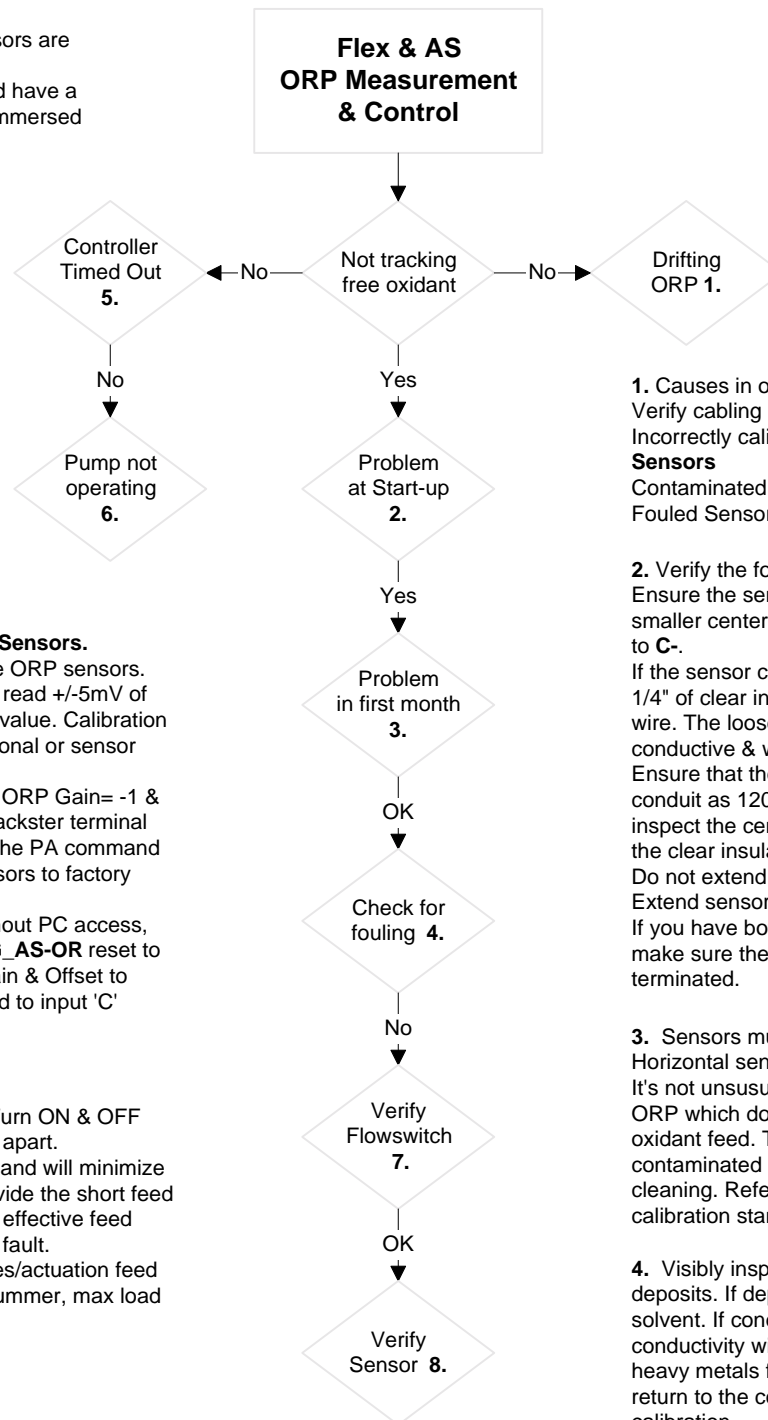
Single junction ORP sensors are RED.
Double junction, flat faced have a bright metal disk on the immersed end.
